Cold Regions Research &  
Engineering Laboratory

### *Measuring thermal performance of building envelopes*

*Nine case studies*

# CRREL Report 85-7

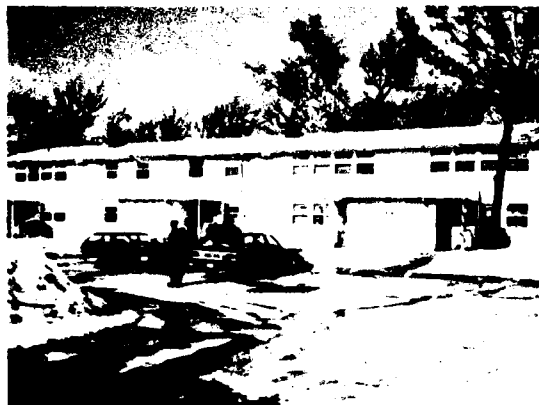
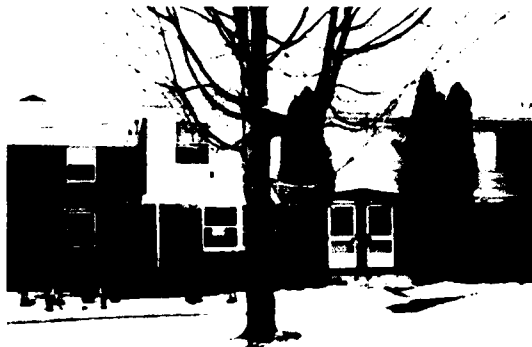
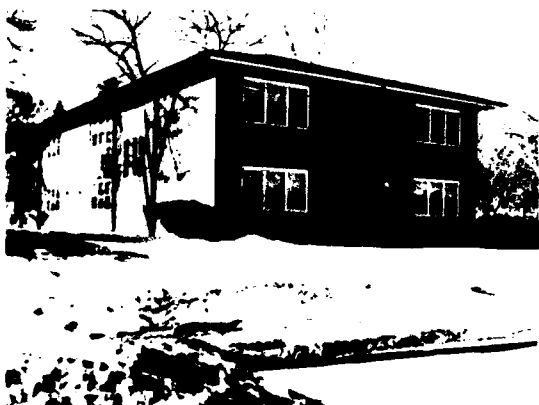
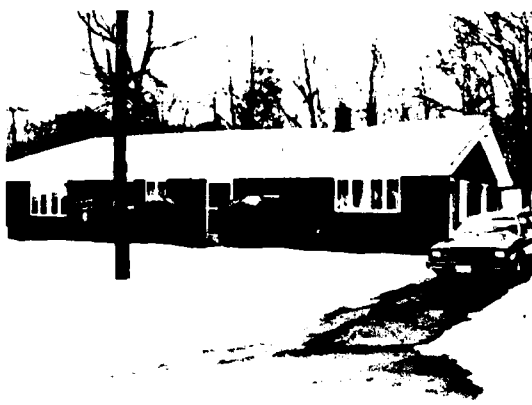
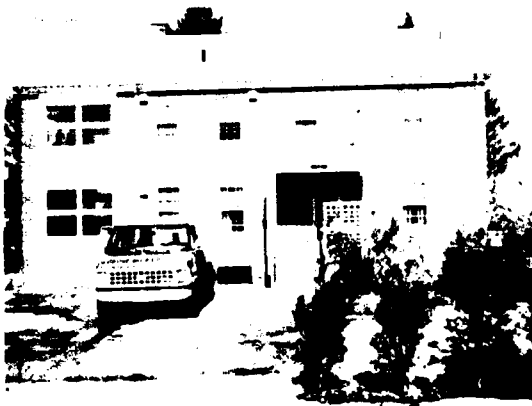
*Figure 1. Examples of the building types studied at Ft. Devens.*

Figure 1 shows typical examples of each building type. For convenience some types are referred

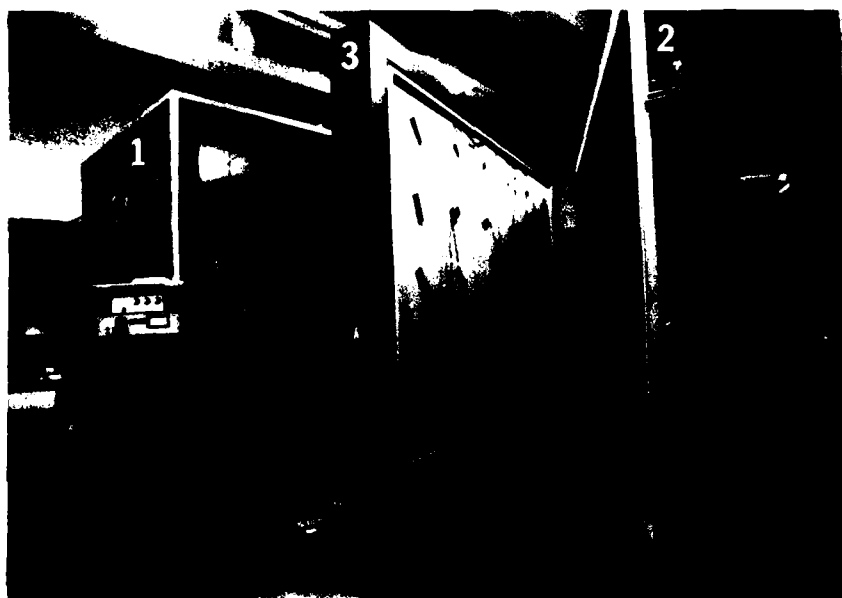
*Figure D1. Calibrated hot box and moisture test facility used to calibrate the HFSs. A refrigerated chamber (1) and a heated chamber (2) maintain a constant temperature drop across a test wall held in a frame (3).*

To simulate the conditions of measurement in the field, the calibration apparatus was a calibrated hot box. The box accommodates wall test sections up to 8 by 12 ft. The wall section employed for the calibration of the sensors was made of 2-in. tongue-and-groove extruded polystyrene taped at the joints with a layer of 0.5-in. gypsum wallboard held against the insulation with springboards.
